PHOTOGRAPHIC INTELLIGENCE REPORT

CLA/PIR 65108

DATE APRIL 1966

A STUDY OF THE NORTH VIETNAMESE RAIL LINE SOUTH OF HANOI

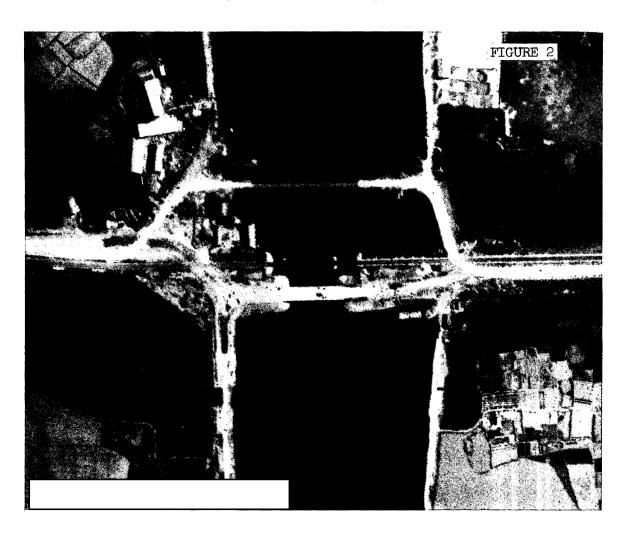
Bridge Number 1 - Co Trai RR Bridge over canal

This 3-span, steel, half-through truss and deck-girder bridge is approximately 160 long.

This bridge has not been bombed.

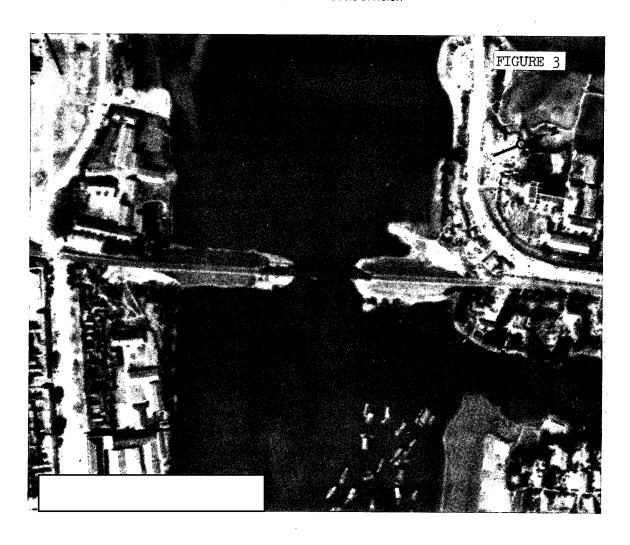
Bridge Number 2 - Phu Ly RR Bridge over Song Lap

This 4-span, steel, deck-beam bridge is approximately 230' long. The two main spans are approximately each and the smaller two spans are approximately in length. One of the main spans is possibly a swing span to allow for passage of water craft on the canal. The Phu Ly bridge was bombed by US aircraft in early resulting in two spans being destroyed. The present status of this bridge is unknown. The volume of rail traffic movements south of the bridge, however, indicates either a ferry or a reconstructed bridge is being used.

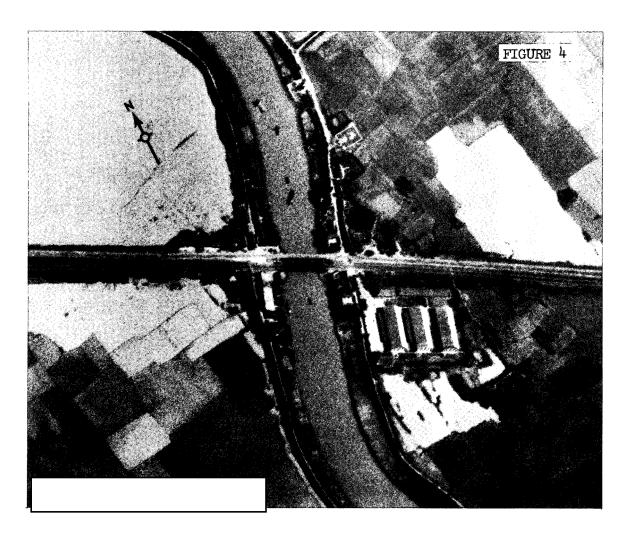
Bridge Number 3 - Cao Duong RR Bridge over canal

This probable 2-span, steel, half-through truss bridge is approximately 125' long. Each span is approximately in length. Available photography indicates that this bridge has not been bombed.

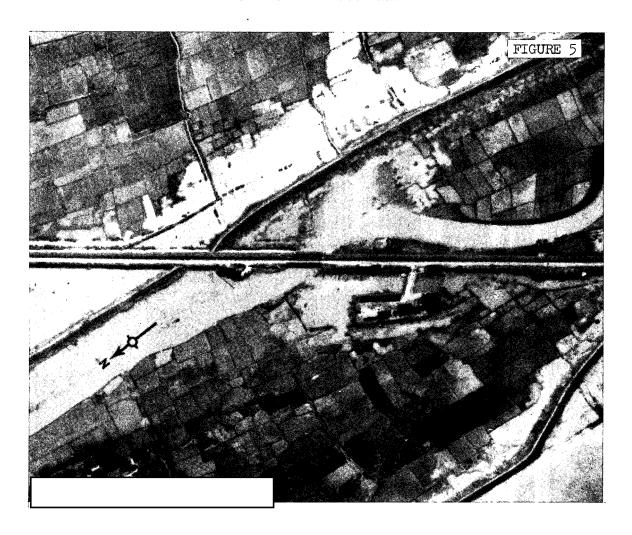
Bridge Number 4 - Ninh Xa RR Bridge over stream

This probable 2-span, steel, half-through truss bridge is approximately 110' long. Each span has a length of approximately 55'. This bridge has not been bombed.

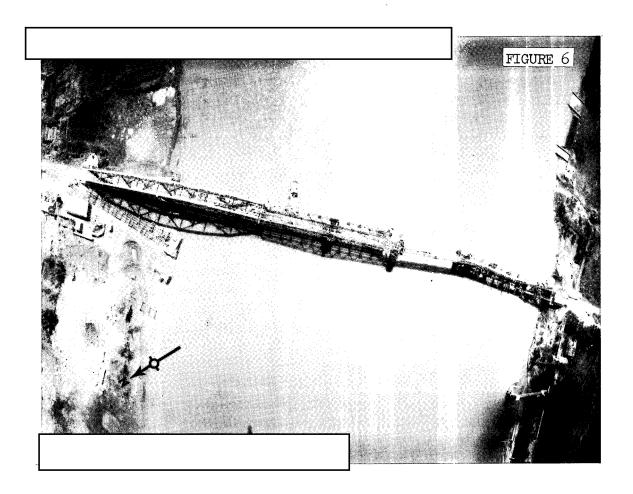
Bridge Number 5 - Ninh Binh RR and Hwy. Bridge over Song Day

This bridge before being damaged by US airstrikes was a 3-span, steel, through-arch truss and half-through truss bridge with an overall length of approximately 680'. The two end spans were steel through-arch truss approximately 260' in length. The center span was a probable steel, half-through truss, swing span for the passage of water craft. The current status of this bridge has not been determined due to lack of photography. Rail traffic south of this bridge indicates there is a method of crossing the river.

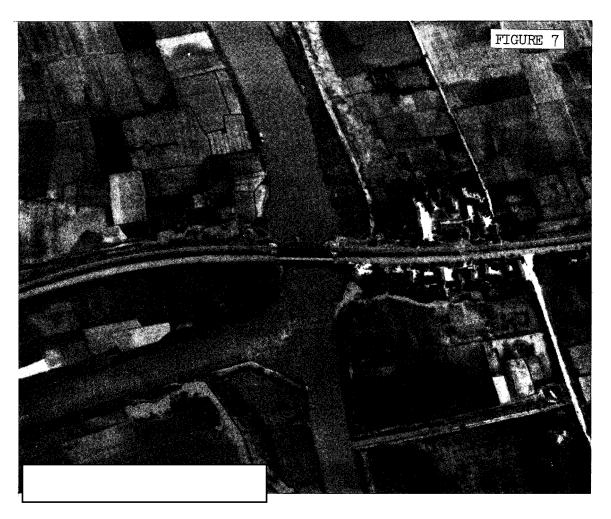
Bridge Number 6 - Ha Thon RR Bridge over Song Vac

This is a 150', single span, steel, through-truss bridge. It has not been bombed.

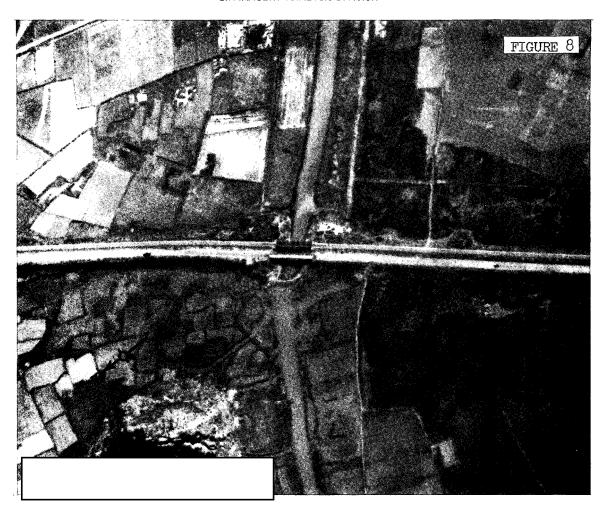
Bridge Number 7 - Ly Nhan RR Bridge over stream

This is a 95', single span, steel, half-through truss bridge. It has not been bombed.

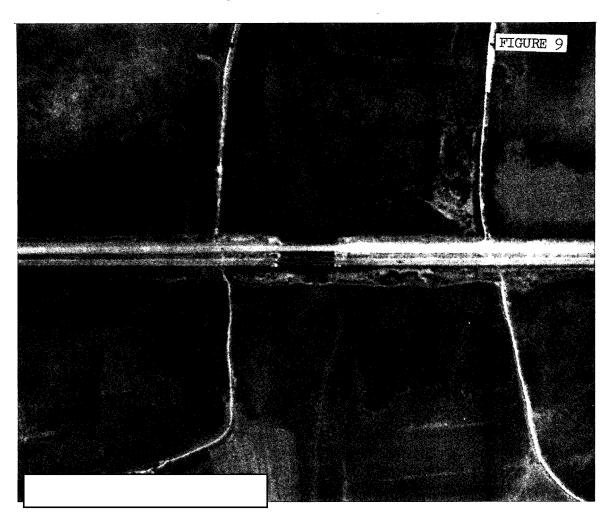
Bridge Number 8 - Bien Son RR Bridge over stream

This is a 120', steel, through-truss, single span bridge with probable concrete abutments. This bridge has not been bombed.

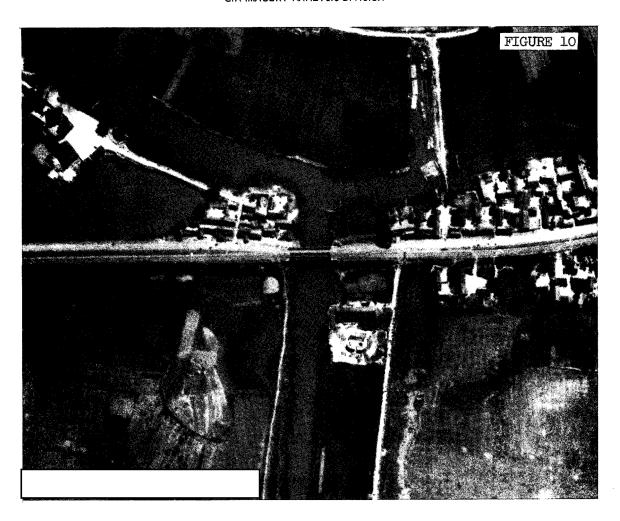
Bridge Number 9 - Yen Xa RR and Hwy. Bridge over stream

This is a 90', single span, steel, half-through truss bridge. It has not been bombed.

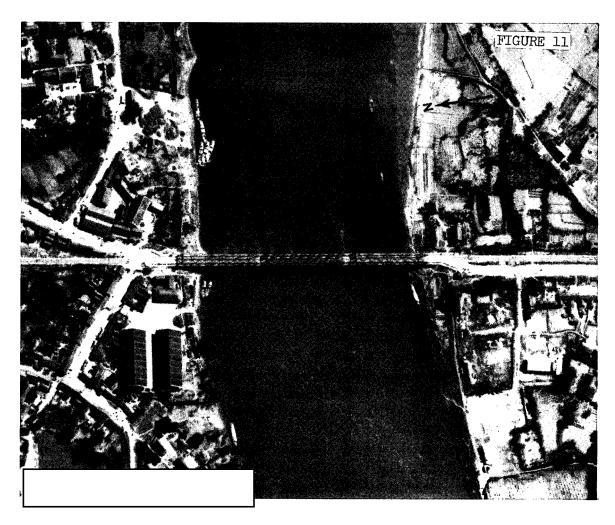
Bridge Number 10 - Dong Phong Thuong RR and Hwy. Bridge over Song Lan

This combination rail and highway bridge was a 450', three span, steel, through-truss structure. Each span had a length of approximately 150'. The three piers are probably concrete. US airstrikes in the fall of 1965 destroyed all three spans, leaving the piers and abutments intact. Since then two by-pass rail bridge have been constructed around the interdicted bridge. These by-pass bridges are probably of the timber trestle type seen further south.

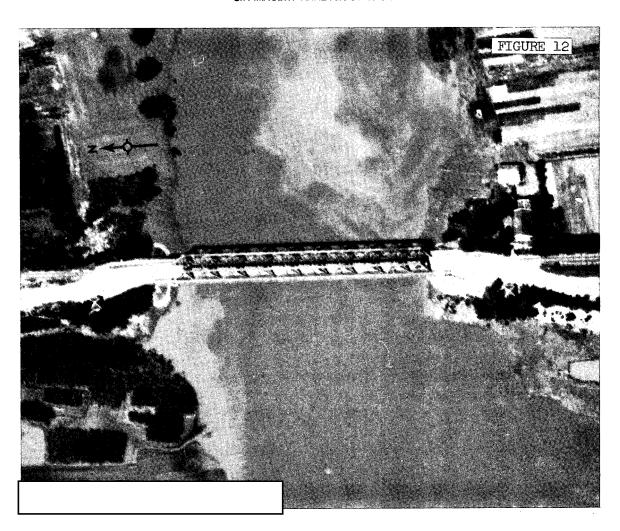
Bridge Number 11 - Phuong Dinh RR and Hwy. Bridge over Lach Truong

This is a single span, $2\frac{1}{4}5^{\circ}$, through-truss bridge. The abutments are probably concrete or masonry. This bridge has not been bombed.

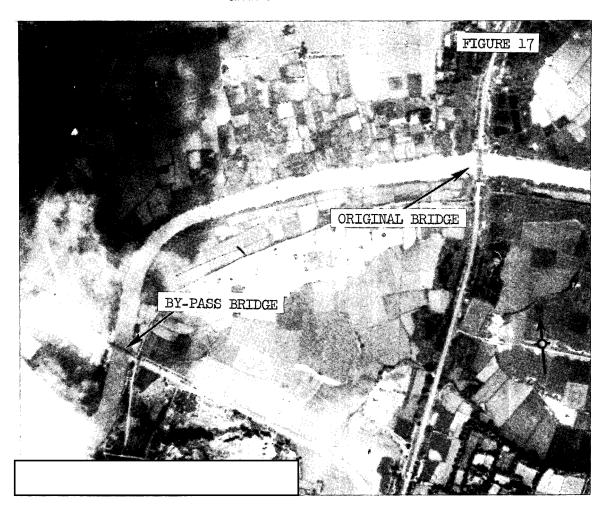
Bridge Number 13 - Thien Linh Dong RR Bridge over Hoang Giang

This 165', two-span, through-plate girder bridge was subject to US airstrikes in early October 1965, resulting in light damage to one span. The damage was repaired and the spans were strengthened by adding another pier under each span. The new piers appear to be of lattice timber construction. In addition to the strengthening of the old bridge, there is a by-pass bridge and rail spur under construction approximately 700 yards to the west of the original bridge.

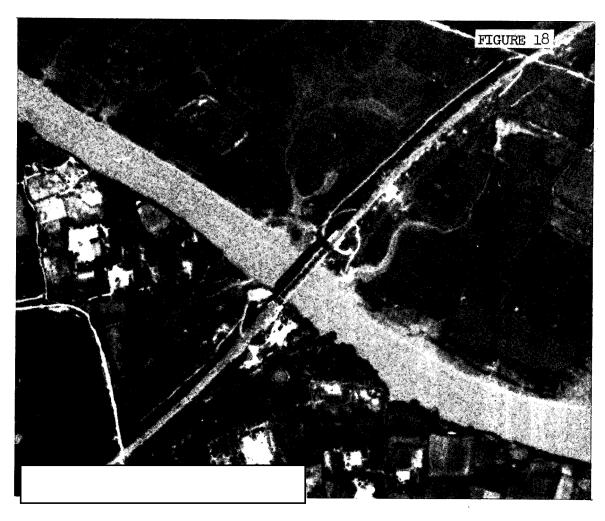
Bridge Number 14 - Thinh Lac RR Bridge over stream

This 2-span, steel, continuous through-truss bridge is 150' long. The pier and abutments are probably concrete. This bridge has not been bombed.

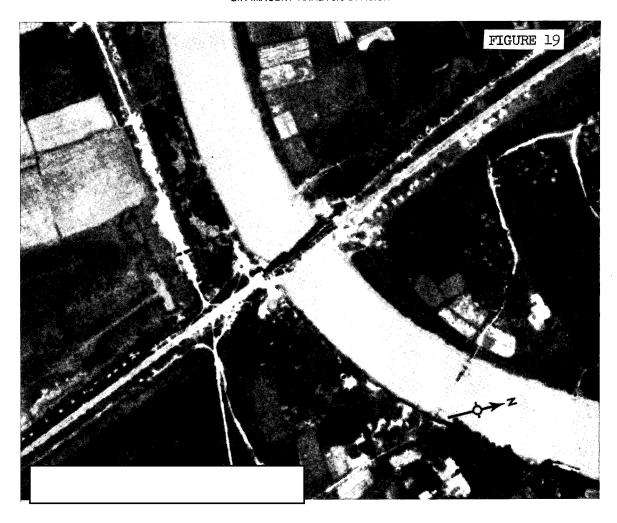
Bridge Number 15 - Truong Quang Tien RR Bridge over Song Yen

This is a 155', three-span, steel, deck-girder structure. US airstrikes in the late summer of 1965 resulted in one span being dropped, and another span being heavily damaged. a rail by-pass bridge and approaches were under construction, but it has been impossible to evaluate further reconstruction efforts due to lack of photography. The volume of rail traffic south of this bridge however, indicates that some method of crossing the river has been accomplished.

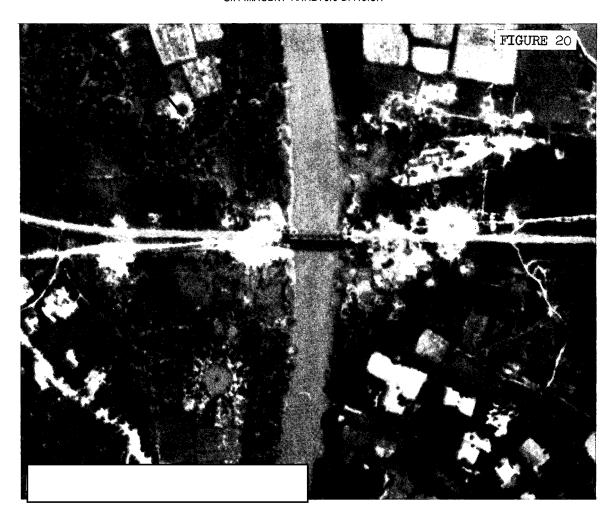
Bridge Number 16 - Thi Long RR Bridge over Suoi Cay Gang

This is a 135', single-span, steel, through-truss bridge. US airstrikes in June 1965 resulted in the approaches being interdicted and slight damage to the superstructure of the bridge. Since that time the approaches have been reinstated and the bridge has been strengthened through the use of a wooden lattice pier under the damaged portion of the bridge superstructure.

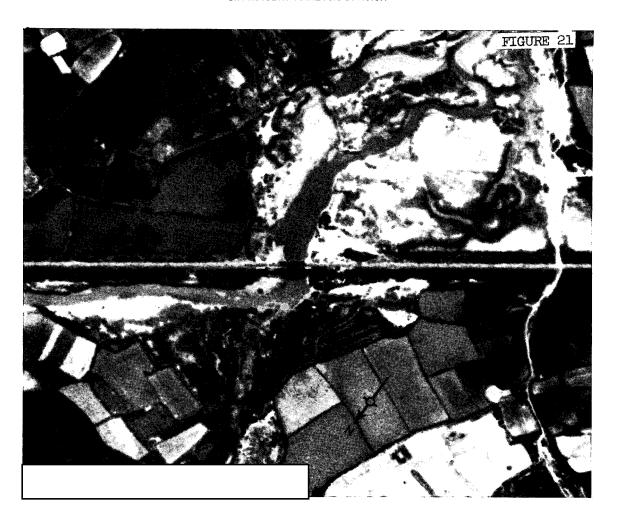
Bridge Number 17 - Phu Quat RR Bridge over stream

This is a 90', single-span, steel, through-truss bridge. The abutments are probably concrete. This bridge has not been bombed.

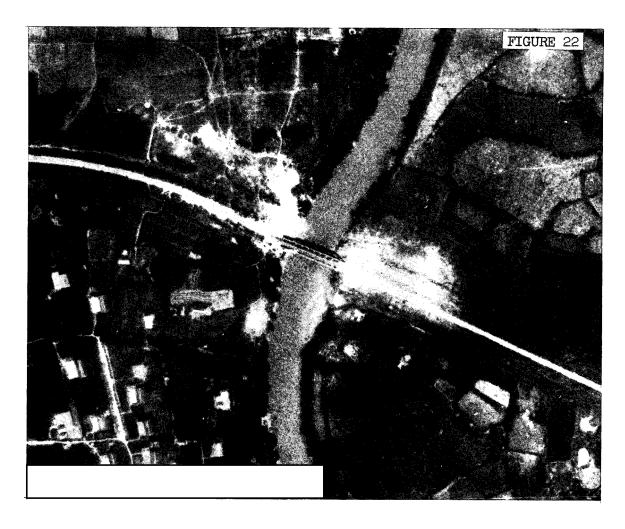
Bridge Number 18 - Dia Thuy RR Bridge SW over stream

This is a 130', 2-span, steel, probable half-through truss bridge. A US airstrike damaged the approaches but the bridge remains intact and the damaged approaches have been repaired. A rail by-pass bridge has been constructed near the original bridge and is ready to be used immediately, should the original bridge be interdicted again. The by-pass bridge is constructed of wood and is a deck beam type with wooden lattice towers supporting the superstructure.

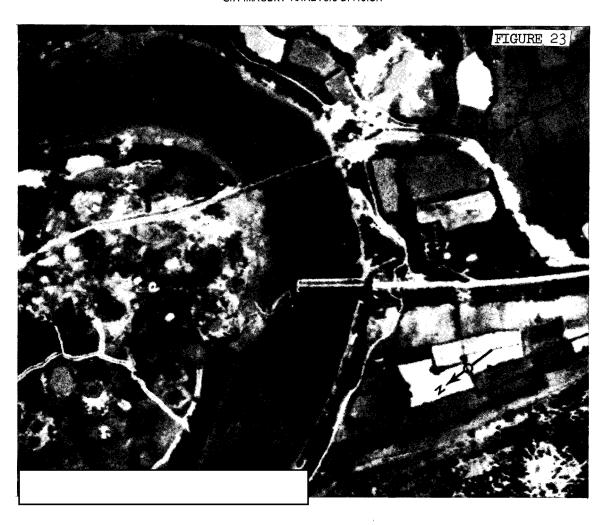
Bridge Number 19 - Qui Vinh RR Bridge over Song Hoang Mai

This bridge, originally a 300', 4-span, steel, through-truss structure with concrete piers and abutments, was heavily damaged by US airstrikes and remains unrepaired. Two spans were dropped and one approach was heavily cratered. Since the above photo was taken, two new rail bridges have been constructed in the vicinity of the original bridge. Both of these bridges are of the timber deck-beam type with wooden lattice piers for support. Rail traffic can be almost immediately diverted from one by-pass bridge to the other in the event of another interdiction.

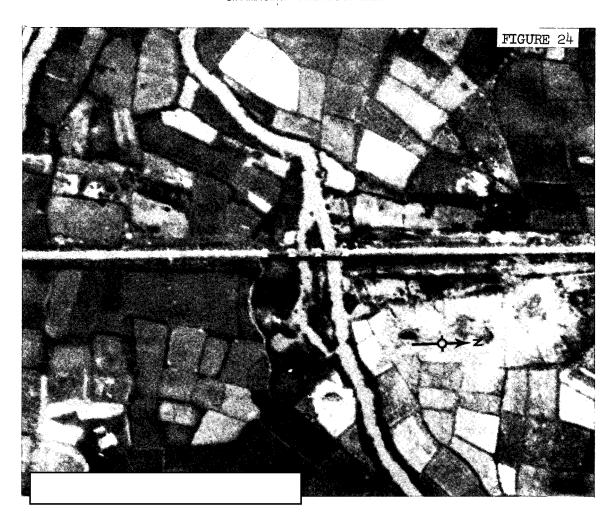
Bridge Number 20 - My Hoa RR Bridge over stream

This bridge is a 115', 3-span, steel, deck-girder bridge. The three piers and abutments are probably concrete. Although subject to US airstrikes, the bridge has not been damaged.

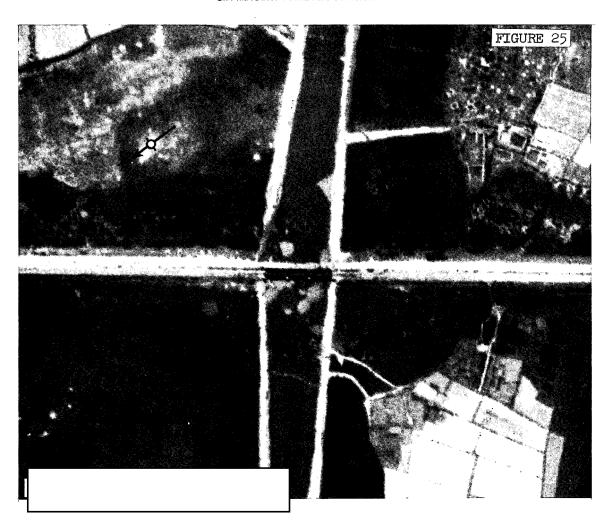
Bridge Number 21 - Long Ngoc RR Bridge over unknown Barrier

This is an approximately 145', 3-span, steel, deck-girder bridge. The piers and abutments are concrete. This bridge has been subject to US airstrikes but remains undamaged.

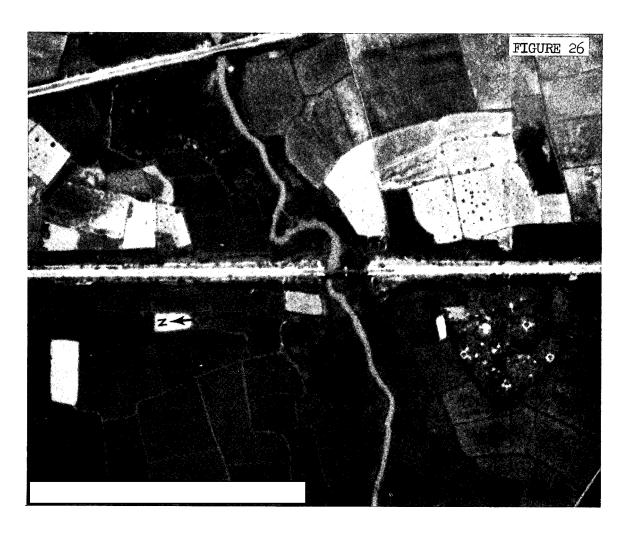
Bridge Number 22 - Dong Khe RR Bridge over stream

This is an approximately 95', 2-span, steel, probable deck-girder bridge. The pier and abutments are probably concrete. The bridge has not been bombed.

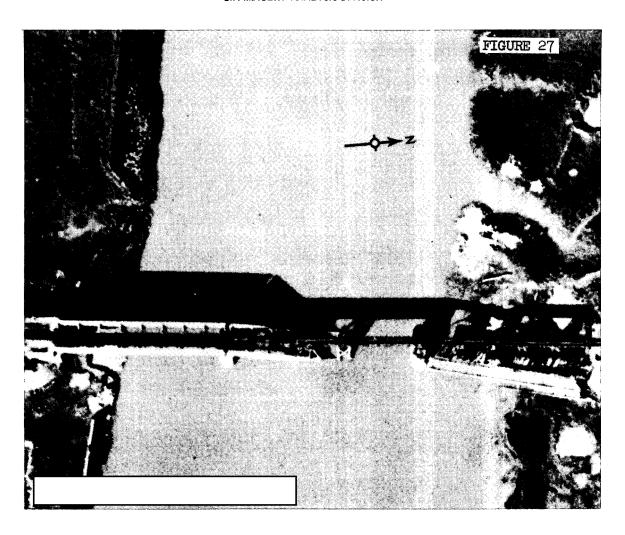
Bridge Number 23 - Dien Chau RR Bridge over Song Bang

This bridge, originally an approximately 350', 3-span, steel, plate-girder structure, had two spans dropped by US airstrikes. Since the airstrikes, the bridge has been repaired by using a timber, deck-beam type construction. One span is possibly an inverted steel truss.

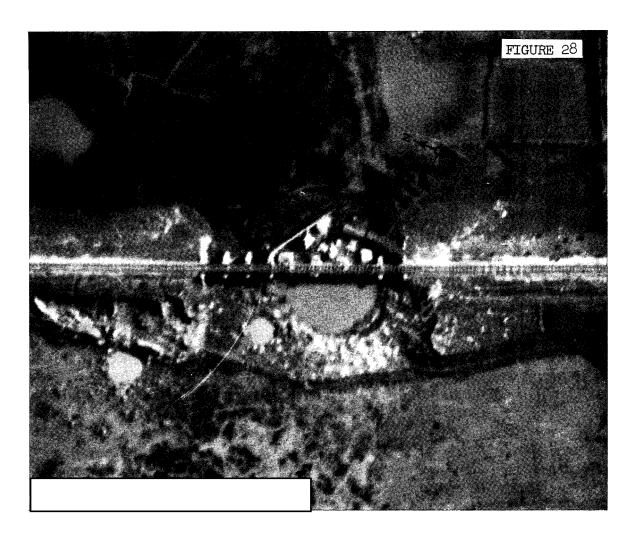
Bridge Number 24 - Da Phuc RR Bridge over intermittent waterway

This is a 135', 9-span, steel, deck-girder bridge with probable masonry piers. Six spans were dropped, another span badly twisted, and four piers were destroyed by US airstrikes. The bridge has been reconstructed using wooden and masonry piers and probable wood, deck-beam superstructure.

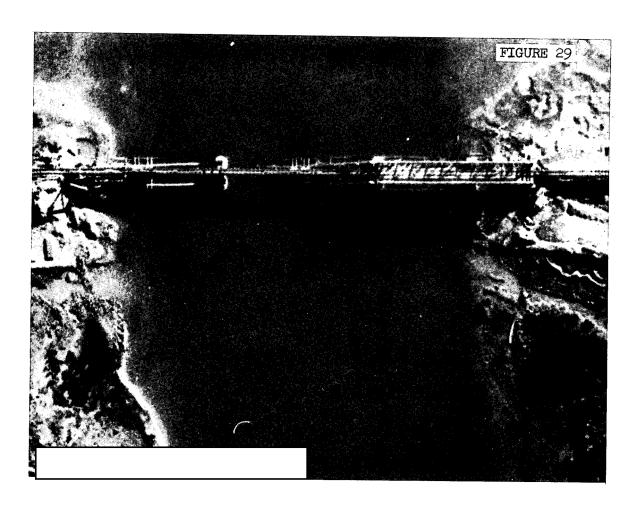
Bridge Number 25 - Tam Da RR Bridge over Song Cua Lo

This was originally a 360', 3 span, steel, half-through truss bridge with concrete piers. Two spans were dropped as a result of US airstrikes. The bridge has been repaired with a wood, deck-beam structure supported by wooden lattice towers (See figure 30). The capacity of this bridge is approximately 7 to 10 tons total load per span.

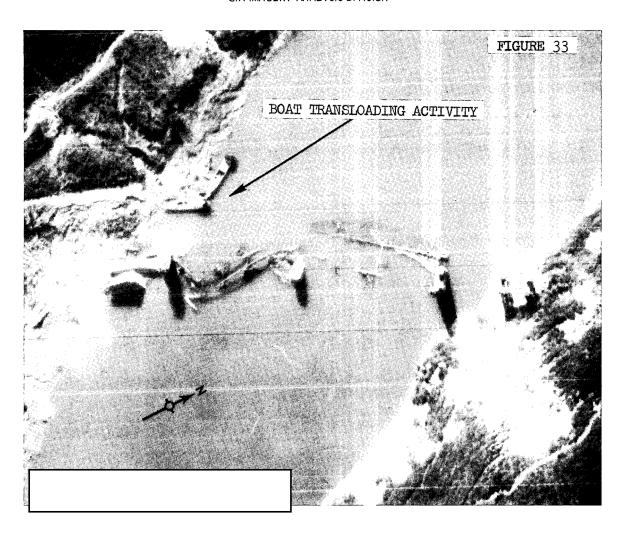
Bridge Number 26 - Trai Hoi RR and Hwy. Bridge over Ngan Sau

This bridge was originally a 4-span, steel and concrete structure approximately 510' long. It had two steel, through-truss spans, one half-through truss span and one concrete deck span. This bridge was completely destroyed by US airstrikes and no attempt has been made to repair the bridge. However, there is a ferry system employing small boats at the site of the destroyed bridge. It appears that trains unload at the ends of the bridge and the material is ferried across the river and then reloaded on a waiting train.

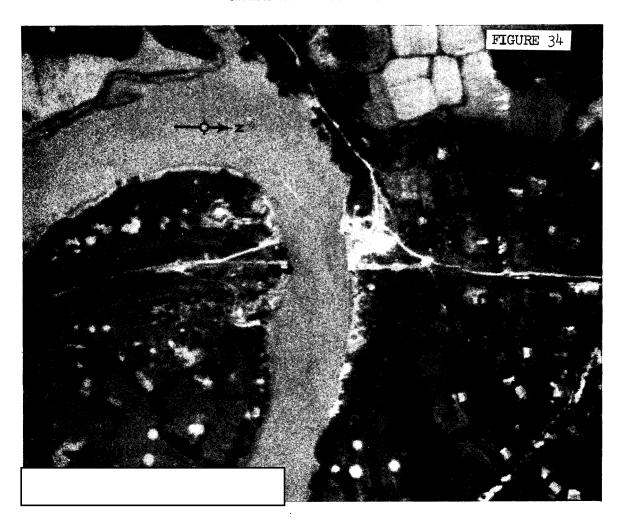
Bridge Number 27 - Phuong Dien RR and Hwy. Bridge over Rao No

This bridge was originally a 4-span, steel, deck-girder structure approximately 160' long. The original bridge was completely destroyed by US airstrikes and no reconstruction has been attempted. However, a light movable pontoon bridge has been observed at this site which could be used by porters to transfer material across the river.

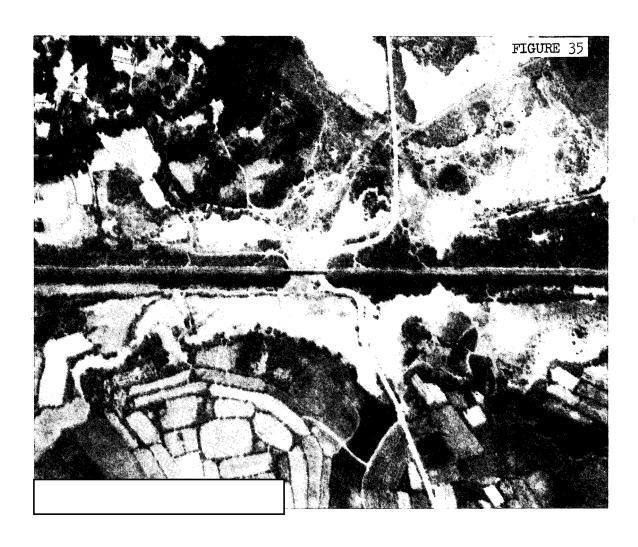
Bridge Number 28 - Xom Bo RR Bridge

This is a 110', 3-span, steel, deck-girder type bridge. This bridge has not been bombed.

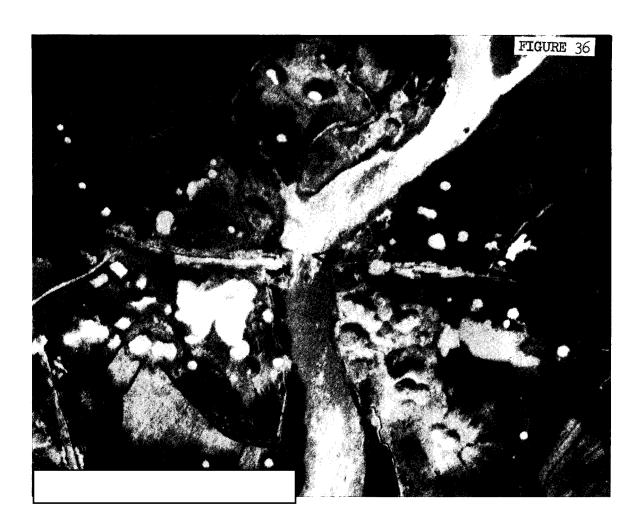
Bridge Number 29 - Dong Bai RR Bridge over Song Tiem

This bridge originally was an approximately 215', 12 to 15 span, timber, trestle bridge. Since it was destroyed by US airstrikes in February 1966, a replacement bridge of the same timber trestle type is under construction. Another probable timber trestle bridge and rail approaches are under construction nearby.

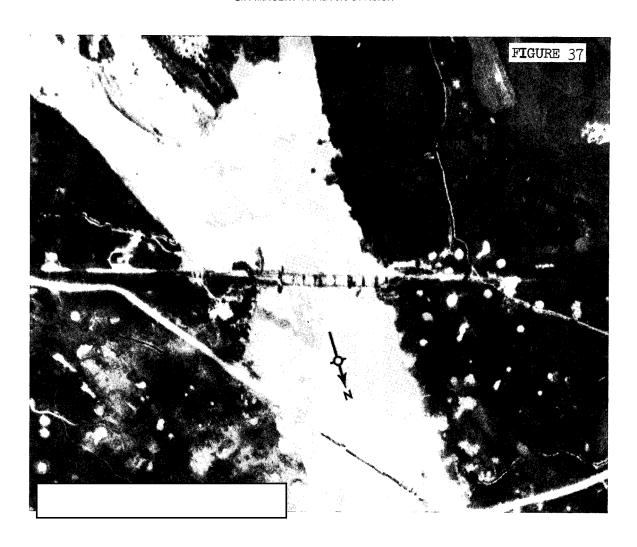
Bridge Number 30 - La Khe Thon RR Bridge over Ngan Sau

This bridge was originally a combination, wood and steel deck beam and half-through truss structure approximately 350' long. It was heavily damaged by US airstrikes in April 1965. Since then the bridge has been reinstated by building a wooden, trestle-type structure at the original bridge site (See figure 38). The capacity of the wooden bridge is approximately 7-10 tons per span total load.

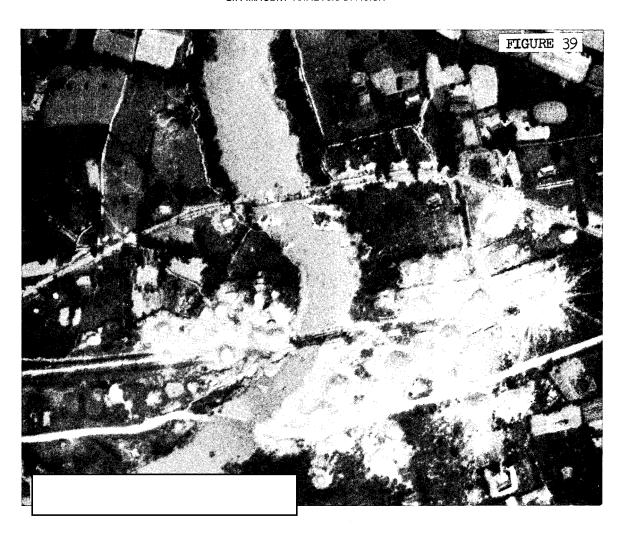
Bridge Number 31 - Bai Duc Thon RR Bridge over Khe Ba Giang

This was originally a single-span, steel, through truss bridge with masonry abutments. US airstrikes dropped the span, and a wooden trestle-type bridge was reconstructed over the wreckage of the old bridge. The replacement bridge was destroyed by US airstrikes in February 1966. Since that time a timber trestle bypass bridge and rail approaches have been constructed about 100 yards west of the bridge (See figure 40). This bypass is now serviceable. The maximum safe load per span is approximately 10 tons.
